**Use of PE 100 supply pipes for the new construction
of the BMW car factory in Leipzig**

Michael Müller-Ruff, graduate engineer, BMW Group, Munich
Thomas Frank, graduate engineer, BMW Group, Mörfelden

**Wiesbadener Kunststoffrohrtage 2004
28 and 29 April 2004**

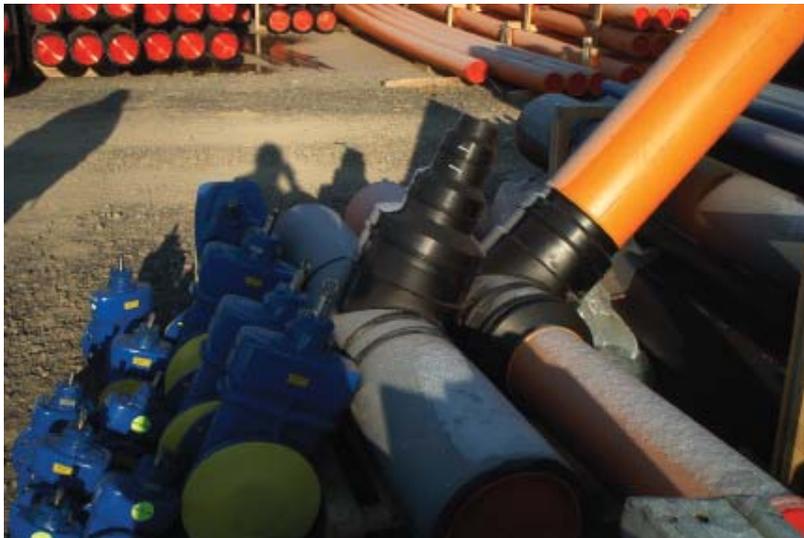
To optimise construction site workflows, a large number of the parts were already pre-assembled at the factory (Photo 1).

Photo 1: pre-assembled branches for gas pipes and fire mains

The pipes and moulded parts were connected by means of thermo-compression butt welding (mainly in the larger dimensions) or through electro fusion welding (small dimensions and connections in cramped spaces).

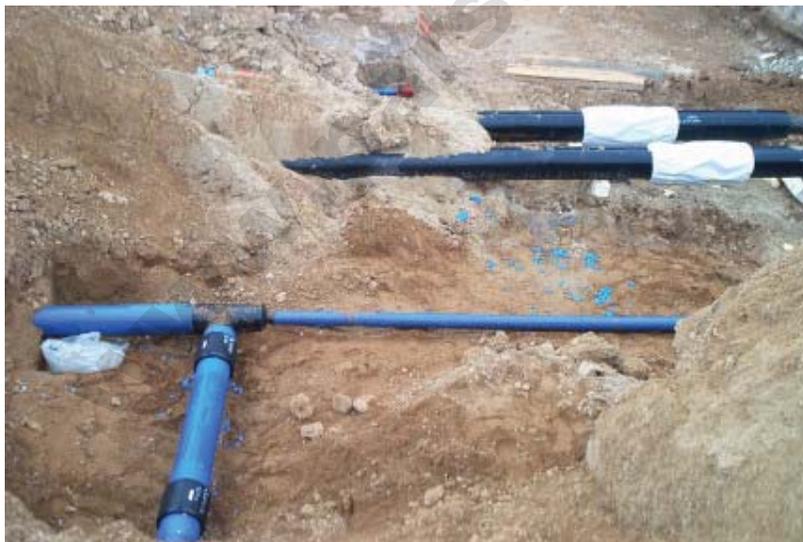
Because BMW's experience with compressed air pipes made of PE 100 was also favourable in the past, the entire earth-laid part of the compressed air network was constructed with the Agruair-System made of PE 100 (Photo 2).

Photo 2: Agruair compressed air pipe and fire main (background)

This pipe system was predominantly connected by means of electro fusion welding due to the smaller dimensions to be welded.

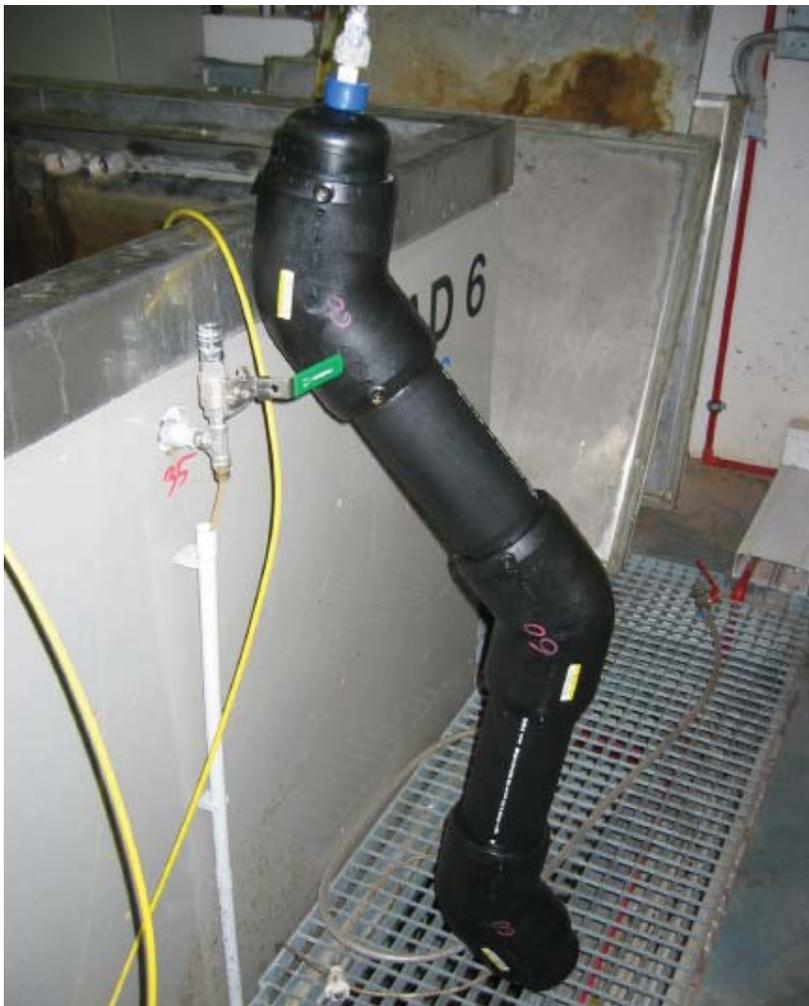
However, the greatest demands on the pipes and moulded parts are made by the prescribed internal pressure creep rupture tests (Photo 4).

Photo 4: Internal (burst) pressure test at a testing stand in accordance with FM standard 1610

These tests must be carried out in two phases every 8 hours. During the first step the components are pressurised with double operating pressure for 5 minutes. There must not be any leaks or permanent deformations during this phase. Then the pressure is increased to the fourfold operating pressure during the second phase. It must be possible to maintain this pressure for 5 minutes as well. Deformations and small leaks are admissible, but leaks that lead to a pressure drop or failure of the components themselves mean that the test was not passed.

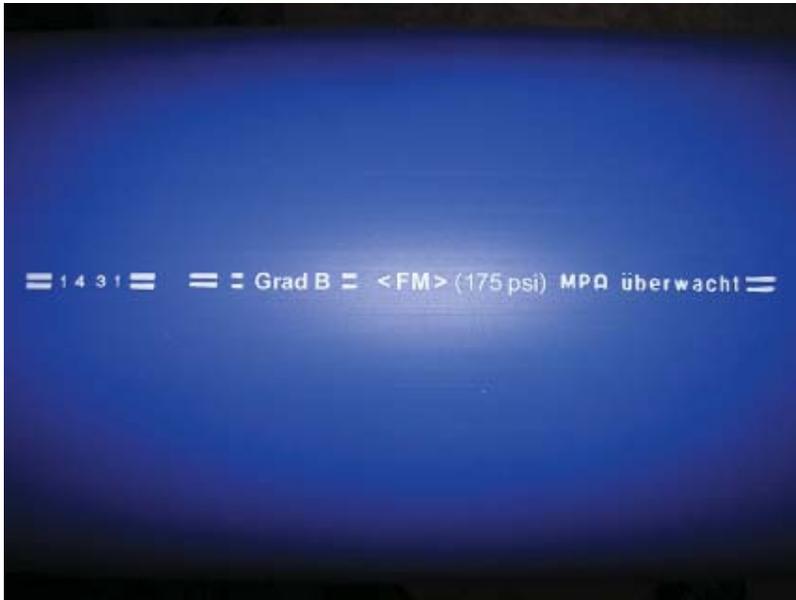
These tests must be carried out on all parts – e.g. also flange joints. Because the inspection effort connected with this is enormous, these tests are carried out to order in normal cases. Parts that were tested in accordance with the approval criteria are specially marked at the factory for these reasons (Photo 5).

Photo 5: Marking in accordance with FM standard 1610

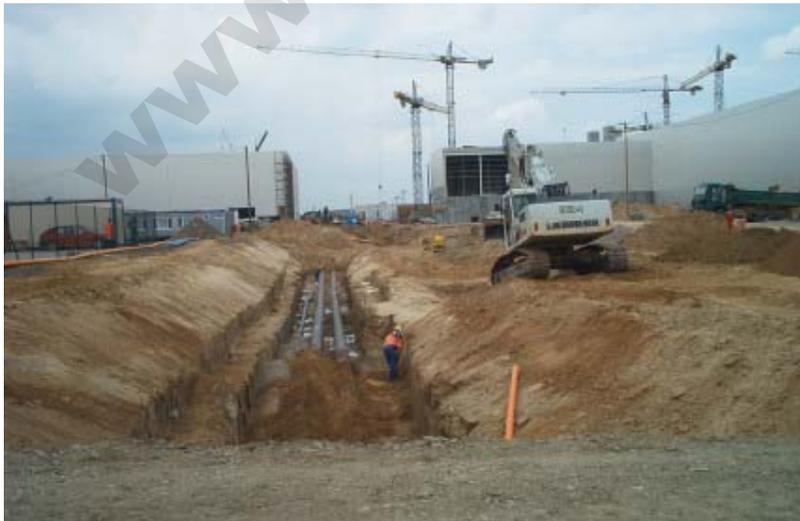
The installation of the supply pipes was largely completed by spring 2003 (Photos 6 to 9). The moulded parts used in the main pipe were constructed with short weld-on ends due to the dimension. Fittings (cast iron) were connected exactly like the adapters in the sprinkler sub-central room with flange joints.

Photo 6: Parallel connecting pipeline to a sprinkler sub-central room

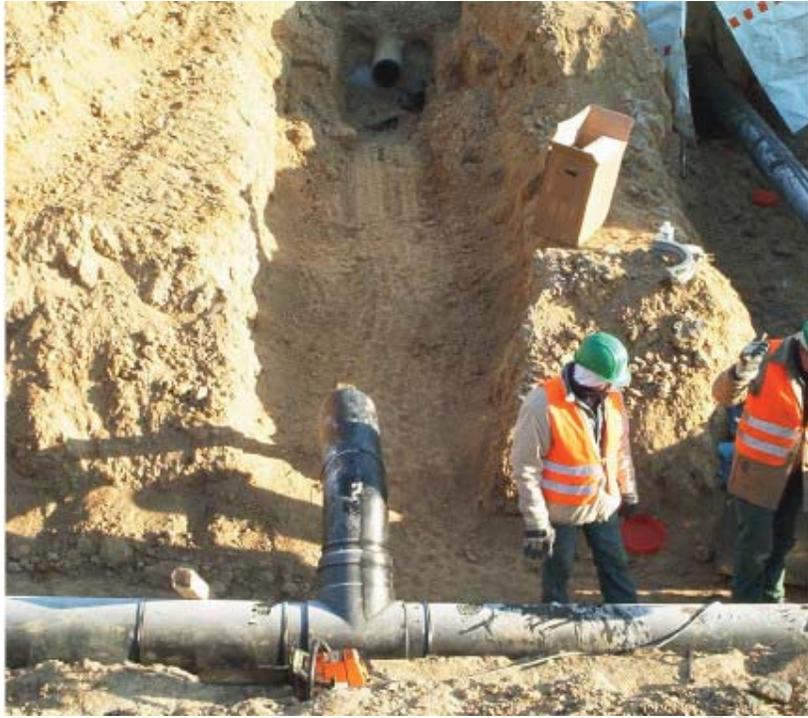
Photo 7: Branch from the main pipeline (DN 300) to the sprinkler sub-central room (DN 250)

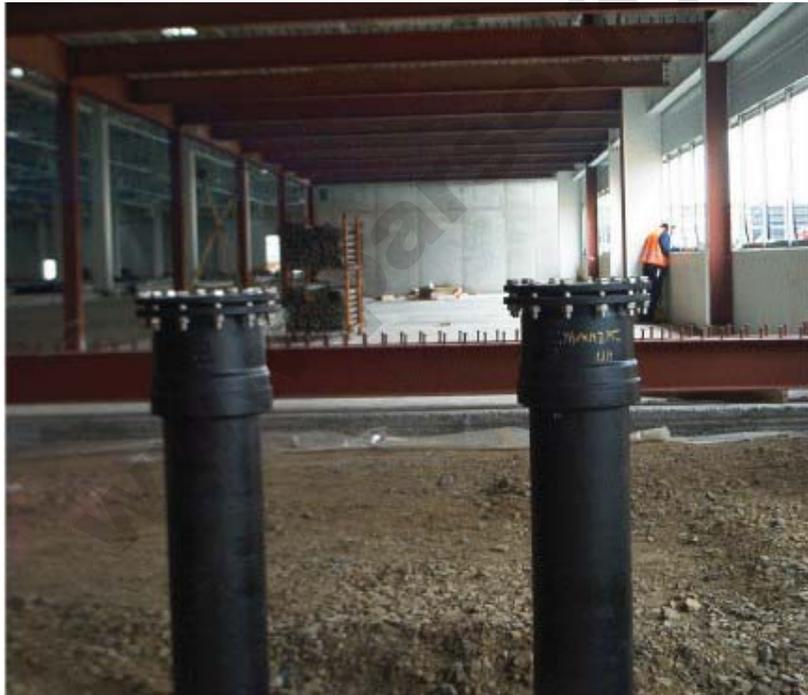
Photo 8: Prepared connection to the sprinkler sub-central room
